Modal Testing and FE Model Updating of a Lively Staircase Structure

Ali Vasallo Belver¹, Stana Zivanovic², HiepVu Dang², Melania Istrate¹ and Antolin Lorenzana Iban³

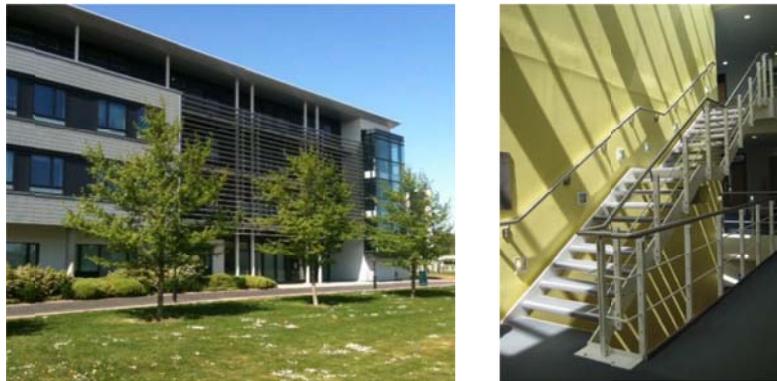
The selected staircase structure was constructed in 2004 and is located in the Zeeman building on the University of Warwick Campus (Figure 1). The staircase is attached to a concrete upper floor and a lower bridge-like structure supported by concrete columns. Around the midspan, the structure is also connected on one side to a side wall by means of two screws (Figure 2). This lively structure is made of steel and concrete. It consists of nineteen steps and a midspan landing. The steps and the landing are supported on two 20 mm thick steel plates. Each step is made of a steel U-shaped base with a mortar infill of 60 mm thickness. The steps are bolted in-between the two side plates. The landing is stiffened by a 120x60x5RHS steel hollow beam framework bolted to the side plates. In addition to the steel plates, the bottom of the stairs is supported by a 120x60x5RHS while the top is supported by a 20 mm thick steel plate. A handrail attached to a steel plate runs along the whole length of the staircase. More information about the geometry of the staircase structure is given in Figure 3.

Figure 1. Zeeman building and staircase structure

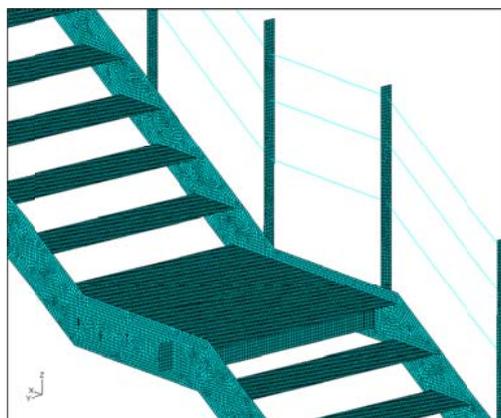
A three dimensional (3D) linear elastic FE model for the staircase structure (Figure 4) was developed using software ABAQUS [7]. The aim was to develop a detailed initial model which would be able to simulate the dynamic behaviour of the staircase as well as possible. This was based on the limited technical data available and the best engineering judgement. The key modelling assumptions were as follows:

- Each part of the staircase structure, except the bars of the handrail, was modelled using orthotropic shell elements (QUAD4).
- The bars of the handrail were modelled using beam elements (BEAM2).
- Side support and supports at both ends of the staircase were modelled as pinned.

Figure 4. Detail of the FE model of the staircase
